Innovative heat exchanger repair

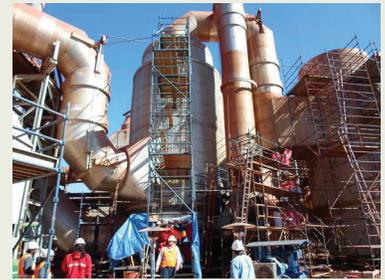
Minara's gas-to-gas exchanger is one of the largest of its type in the world with approximately 3,762 tubes and over 30 feet in length.

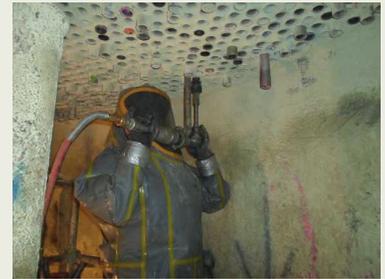
Proper PPE, specialized equipment, VIP International's experience and a joint venture attitude was attributed to the success of the repair.
